Problems Facing the Reuter Organ

Our current organ was built by the Reuter company and commissioned in February 1971. Since then it has served the congregation well, but it is now in the very last phase of its usable life. Several organ builders, acousticians, and organ consultants have assessed our organ and our sanctuary. Here's what we learned from them.

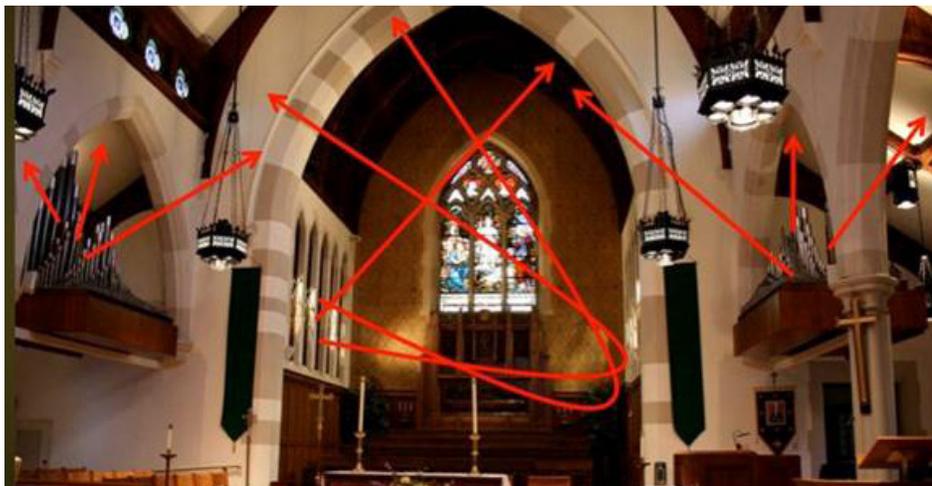
Non cased pipes in different locations can't form a coherent sound due to the vastly different paths they must travel.

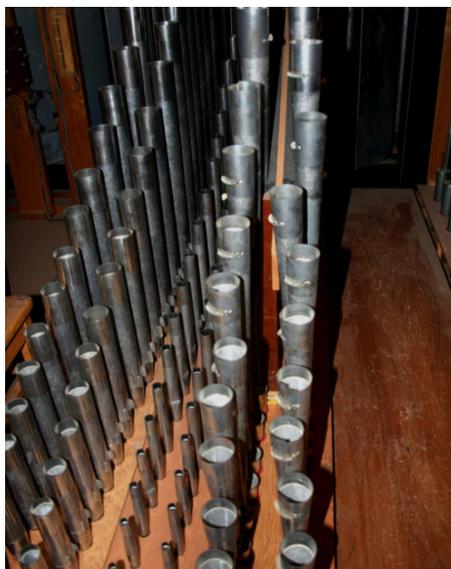
Some pipes are bending and collapsing.

Can we recycle any pipes? Bass pipes are the most expensive due to their size, but our organ builders do not recommend using the Reuter bass pipes due to their inferior material (zinc), and the fact they are heavily mitered (bent to fit under the ceiling). The pipes would have to be straightened, which would cost as much as making new pipes.

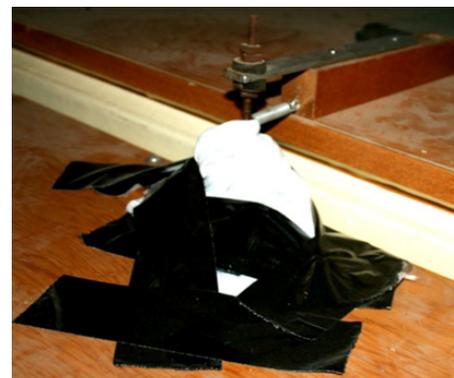
The electronic components in the organ are over 40 years old, and they urgently need replacement. The wiring has been patched together with duct tape. And the leather pouches that encase the ends of the pipe have dried out and cracked. In one instance the nipple from a baby's bottle has been used as a temporary replacement.

As a result of this slow and irreversible degradation, 30 percent of the organ cannot currently be used. The organist must work around certain stops and certain pipes that simply do not work. As time passes more and more of the organ will be rendered non-functional.
